**OPERATIONAL REPORT ON
THE NASA 1965 AIRBORNE
SOLAR ECLIPSE EXPEDITION**

*by Michel Bader, Louis C. Haughney, Glen W. Stinnett,
and Richard A. Acken*

*Ames Research Center
Moffett Field, Calif.*

NATIONAL AERONAUTICS AND SPACE ADMINISTRATION - WASHINGTON, D. C. - MAY 1966

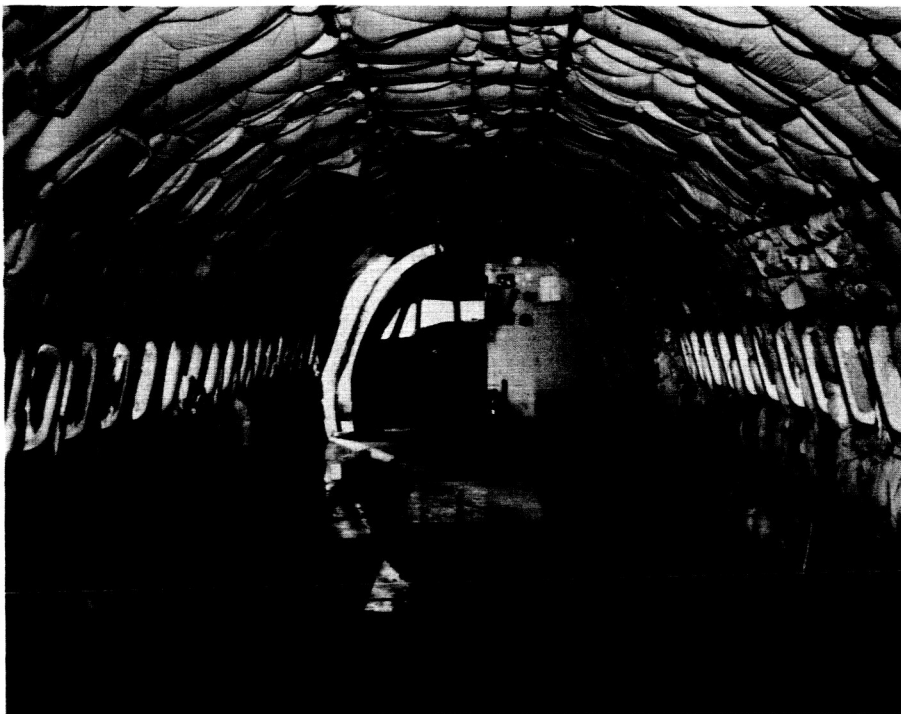
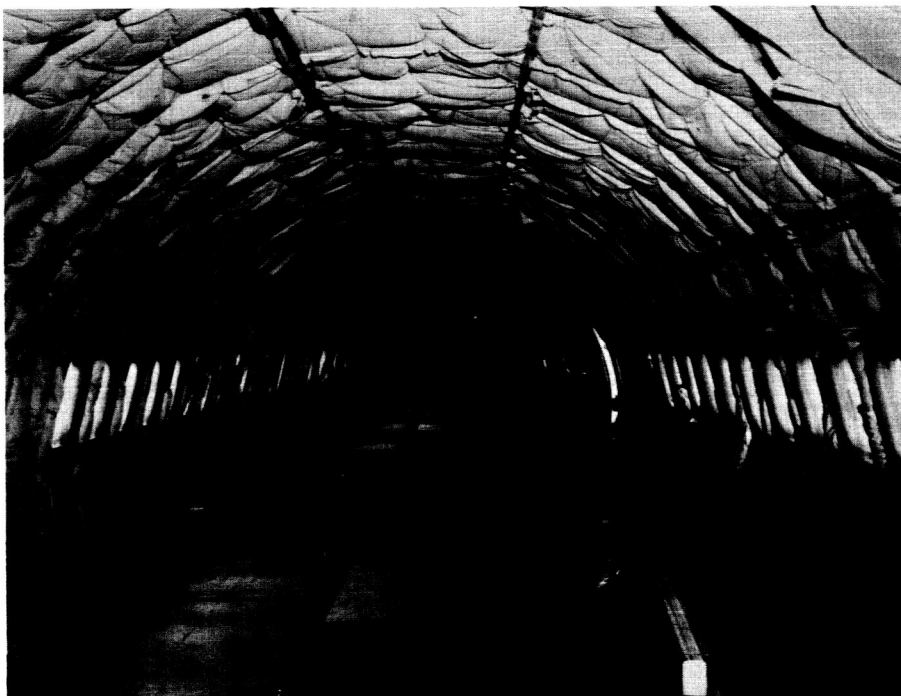
(a) Looking forward.

(b) Looking aft.

Figure 1.- Aircraft interior at time of purchase (October 1964).

In October 1964 NASA purchased a Convair 990 four-engine jet transport for research purposes. This aircraft had been used for flight testing and certification, and was altogether void of passenger accommodations (fig. 1). This made possible, within limits, the optimization of the design and location of various systems. The modified interior is shown in figure 2. Most significant for the 1965 solar eclipse expedition was the cutting of 13 viewports on the airplane's left, at 65° elevation (figs. 3 to 8).

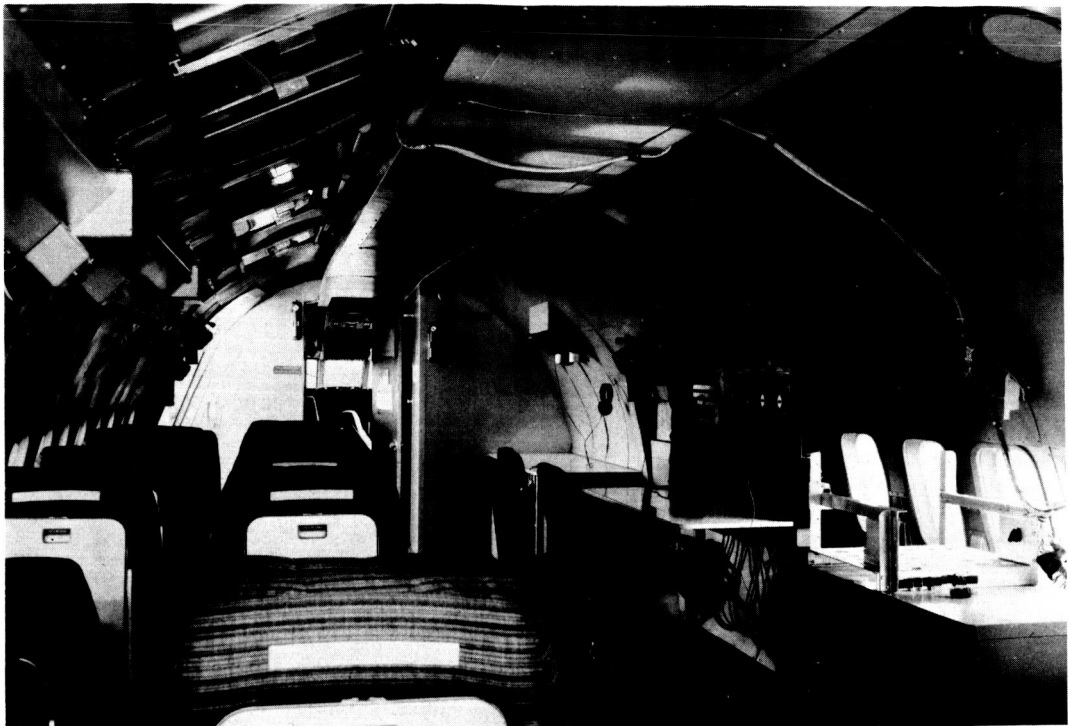
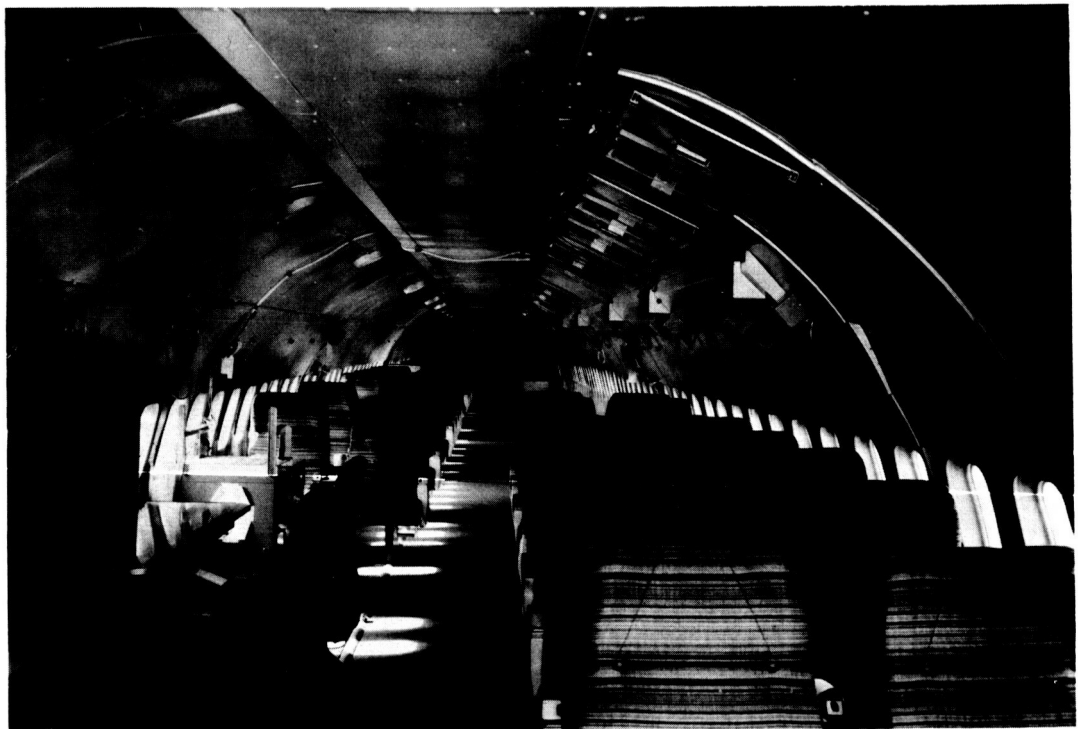
(a) Looking forward.

(b) Looking aft.

Figure 2.- Aircraft interior after modifications (May 1965).

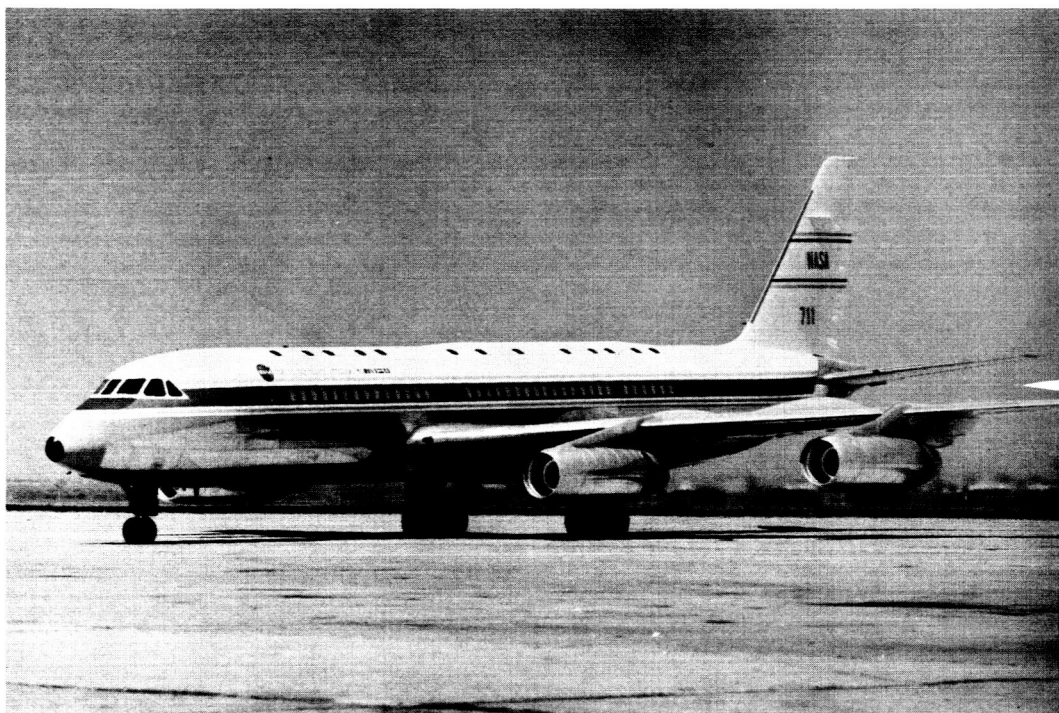
Figure 3.- Overall views of the expedition aircraft. Note in particular the 13 overhead ports. The black paint on the left wind pods and nacelles was intended to minimize reflections into the overhead ports.

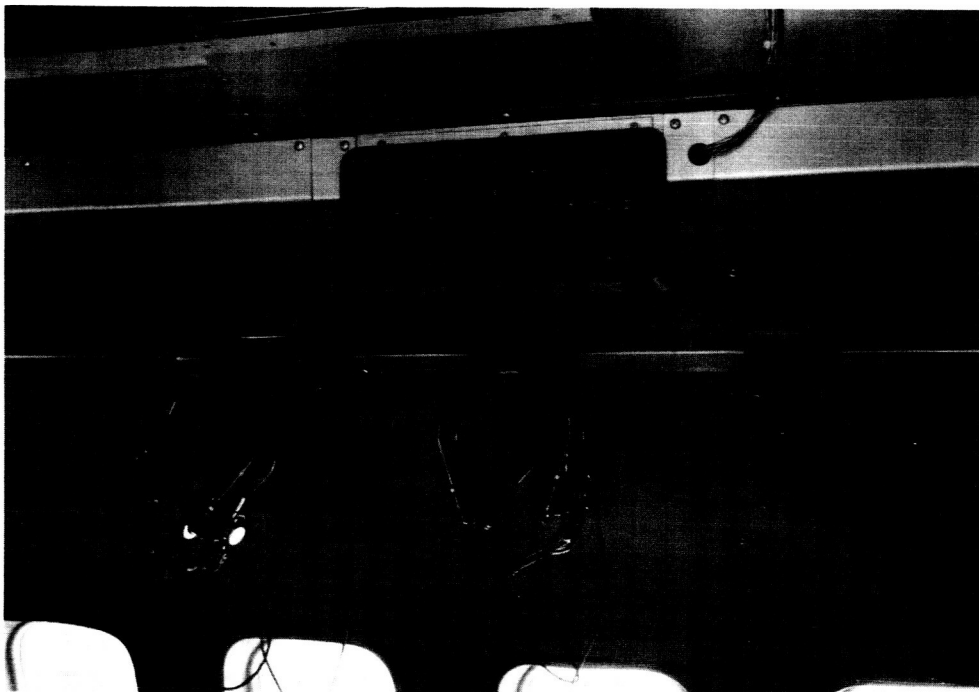
Figure 18.- Typical electrical outlet and intercom system boxes serving two adjacent experimental stations. The small receptacle to the right of the dual electrical box is wired to the time code generator.

The distribution of power to the 16 experimental stations is controlled at the coordinators' console (figs. 4, 17). The power is brought out at dual junction boxes serving pairs of experimental stations (figs. 4, 18).

The time code generator is located on top of the tool cabinet just aft of the coordinator's console (figs. 4, 19). Output leads were run directly across the ceiling to the gutter strip (along the left-hand wall) that contains the power wiring to the experimental stations (fig. 18). The time signal leads are brought out in a BNC connector beside the electrical power junction box at each experimental station (fig. 18).

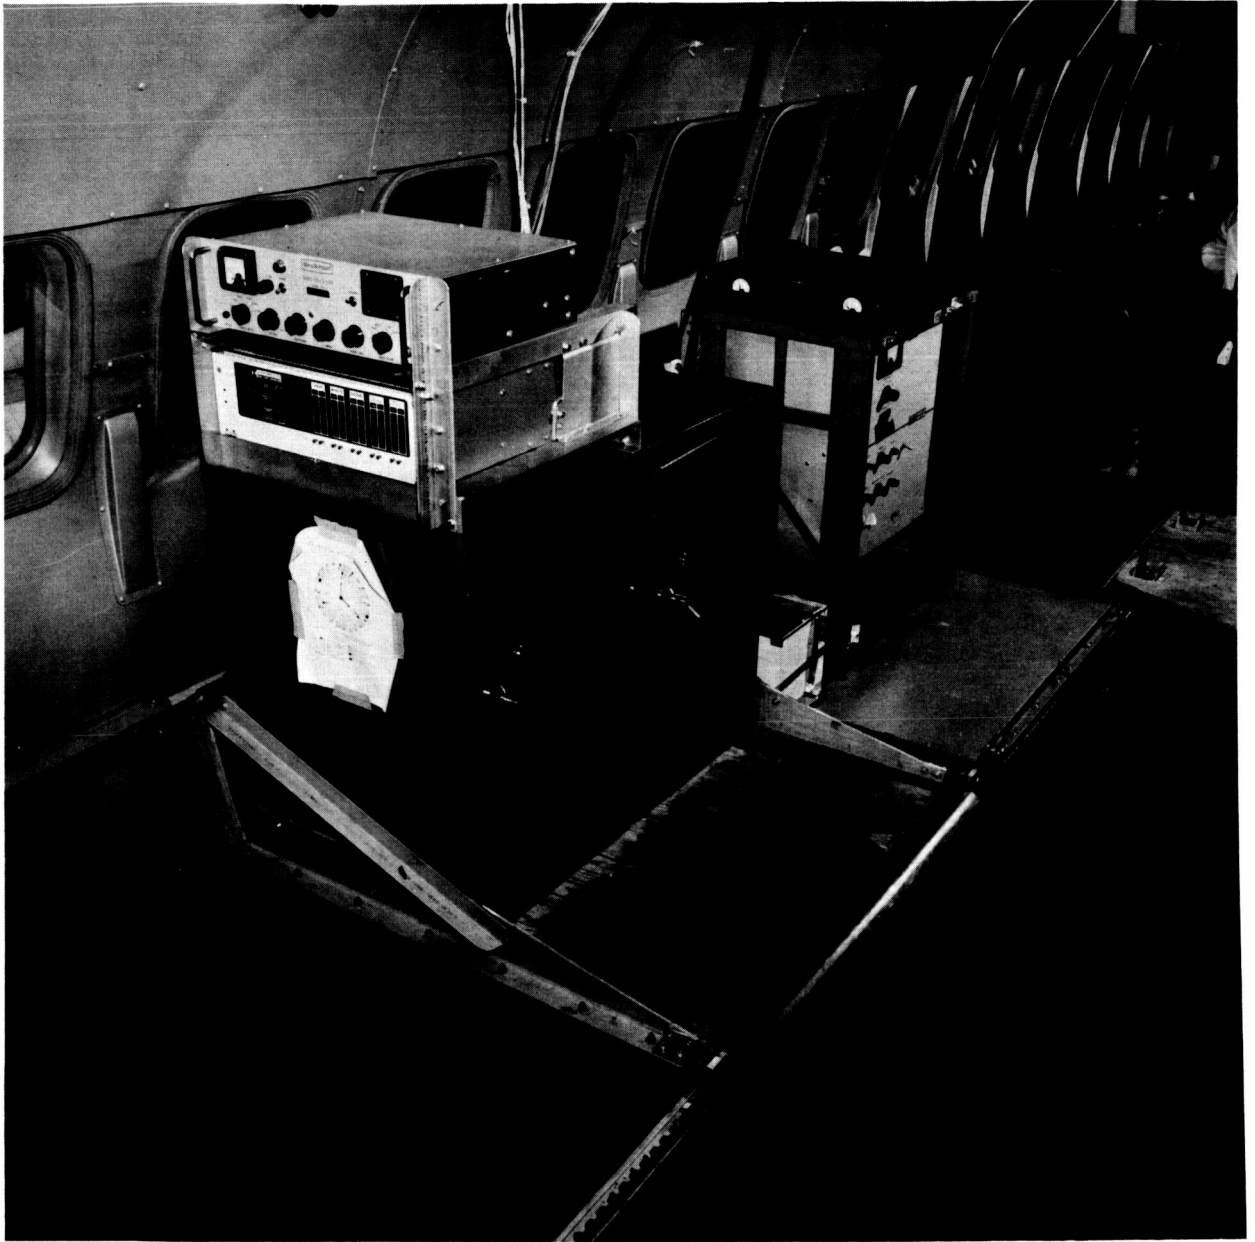
Figure 19.- Time code generator, WWV receiver, and auxiliary dc power supplies.
